## Appendix E: Northwest E6028Y

### Field Notes and Pictures

Utility: ComEd      Investigators: J. Stutsman & J. Spencer

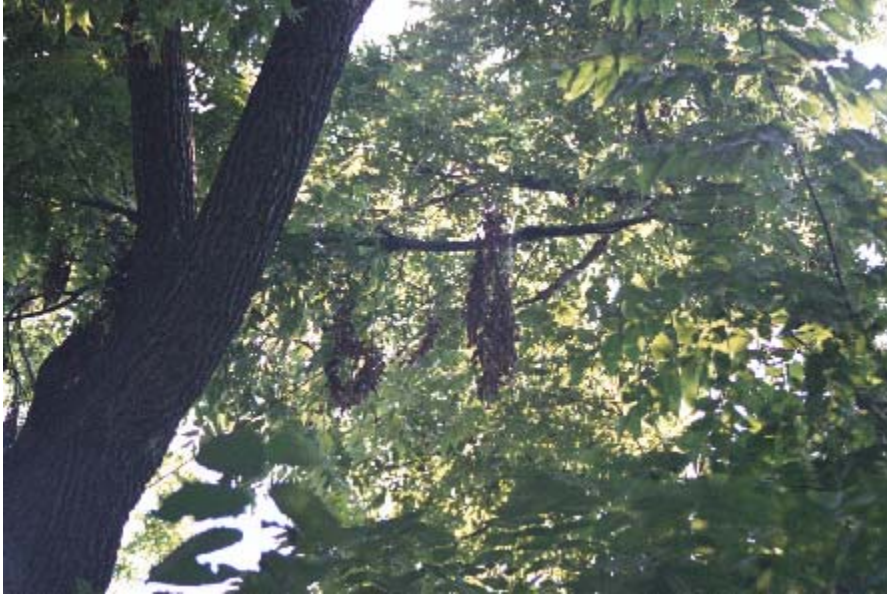
### Picture E1

Bare primary with broken branch (1-2" dia. & 15' long) laying on it at 110 Deepwood Rd. in Barrington Hills

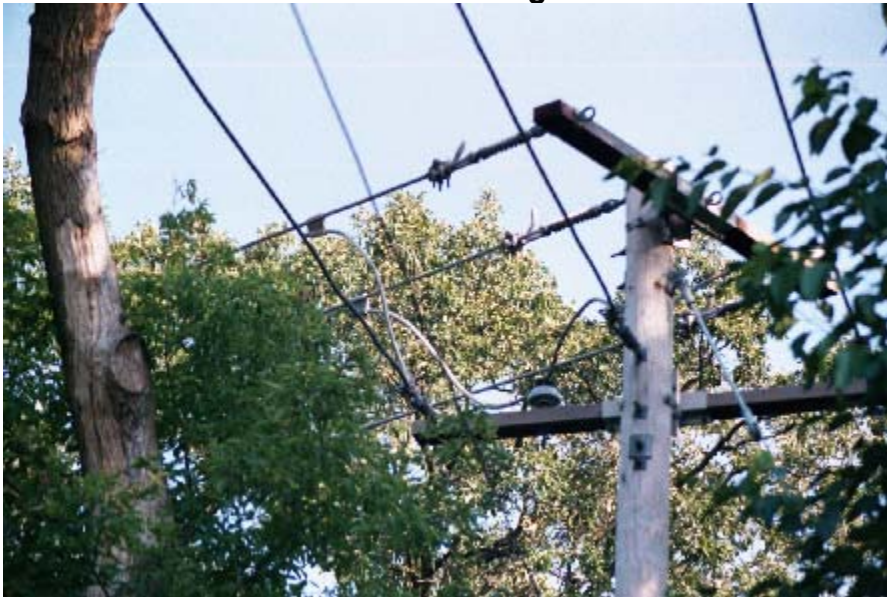
### Picture E2

Bare primary in trees at tap with burning of trees near corner of Helm Rd. and Sioux Ave. in Barrington Hills

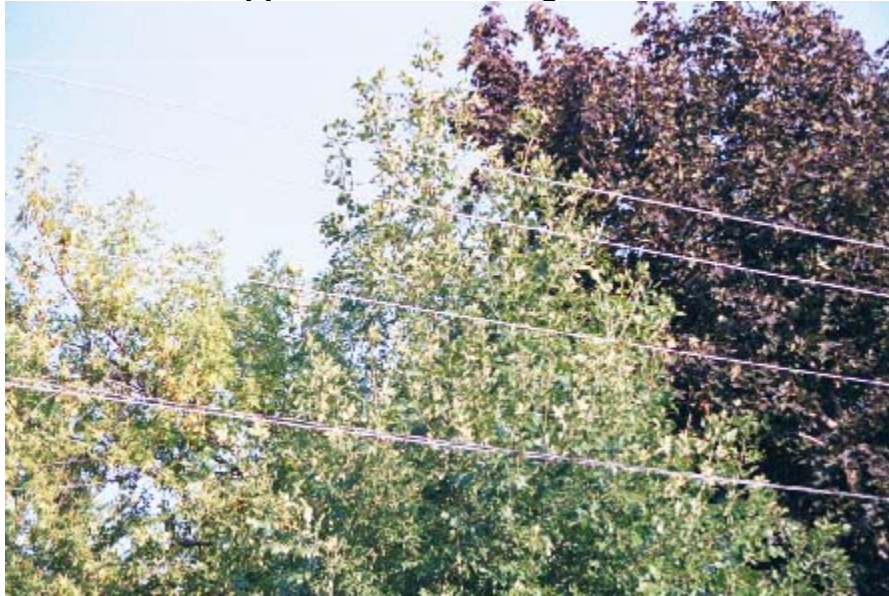
### Picture E3

Field side of bare primary in tree with burning visible across street from 1726 Pappose Rd. in Barrington Hills
